# **EXAMPLE Irrigation Scheme**

## **Farm Water Access Plan: FWAP-TI-000 for Schouten Passage Merino Co.**

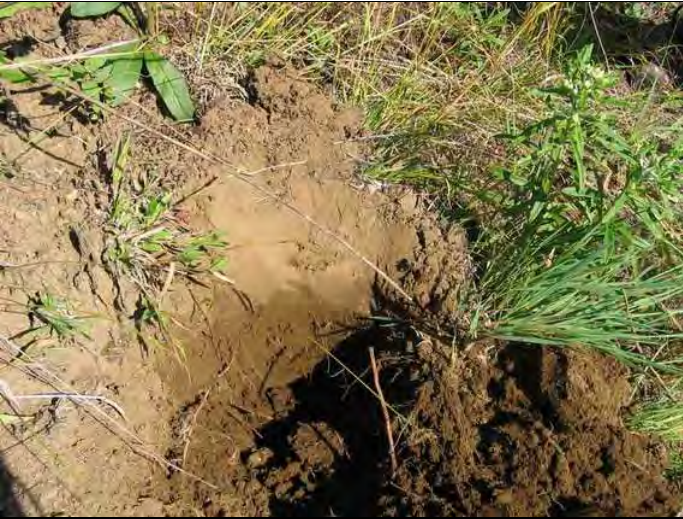
| Evidence of the sandy soils found across the TI irrigation area. | Evidence of wind erosion across class 4a soils. |

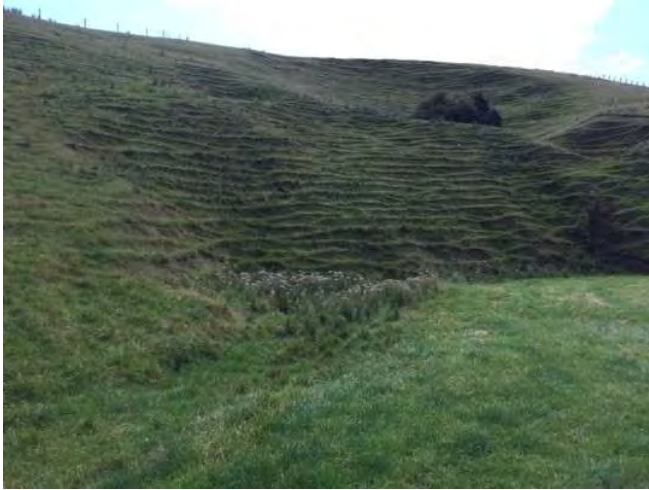
Section of mass movement/ soil creep in class 6e soil areas.

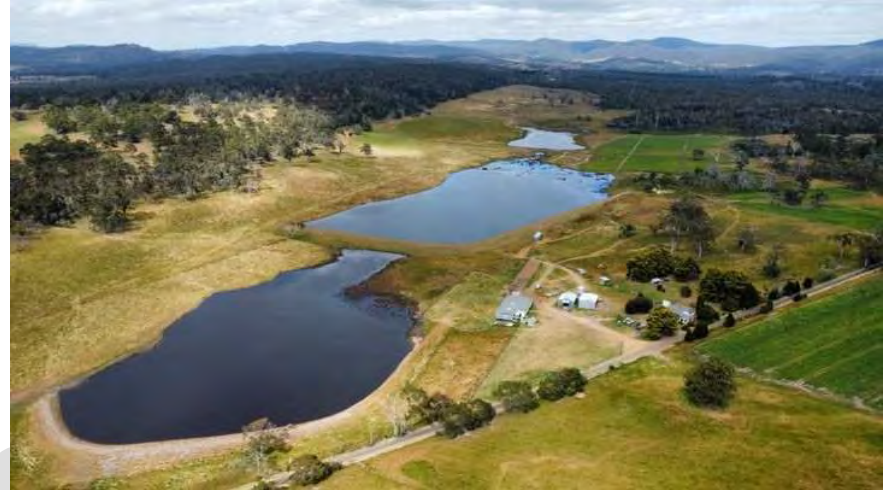
Class 5w soil area comprising a defined watercourse (Seabyrne Creek), extending across Dams 1–3.

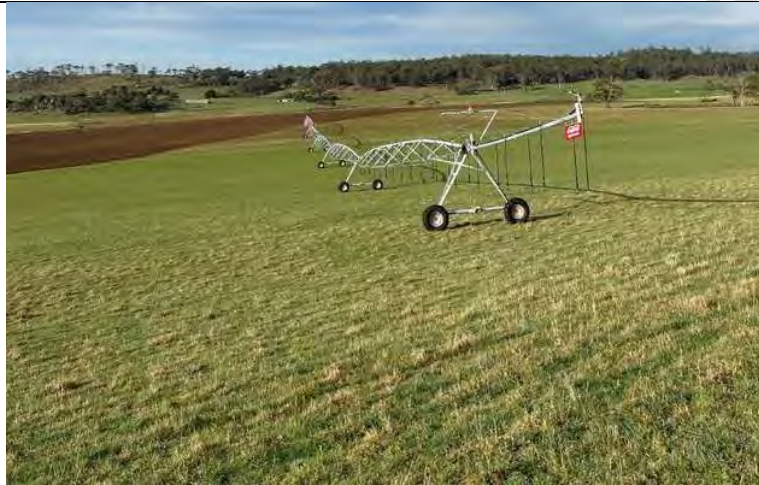
Existing 30-hectare irrigation area exhibiting consistent ground cover, with a section of exposed soil across approximately one-third of the rear pivot area, currently under preparation for sowing.

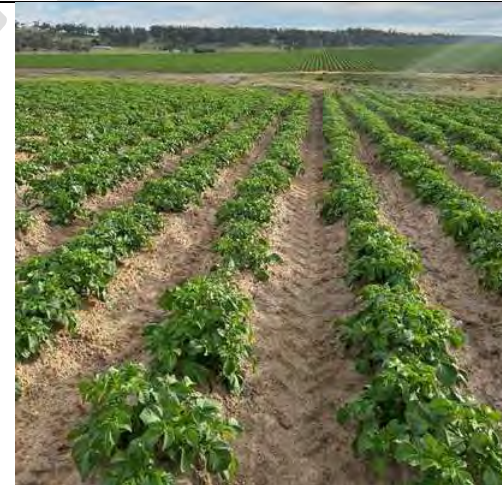
Evidence of a potato crop present within a section of the existing 30-hectare irrigation area, characterised by Class 4a Kandosol soils with sandy to loamy surface textures.

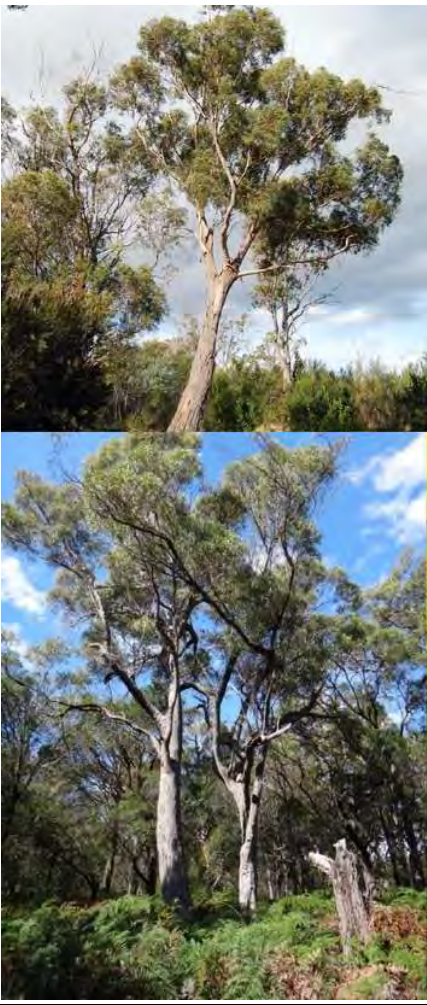
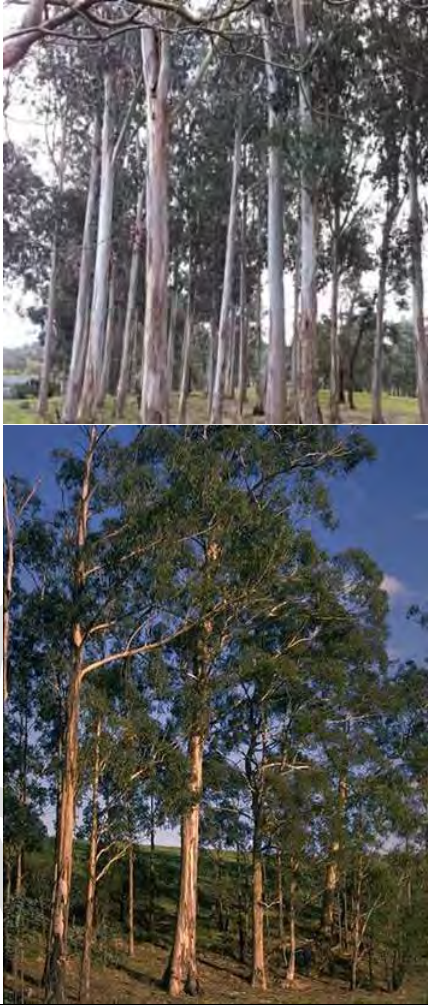
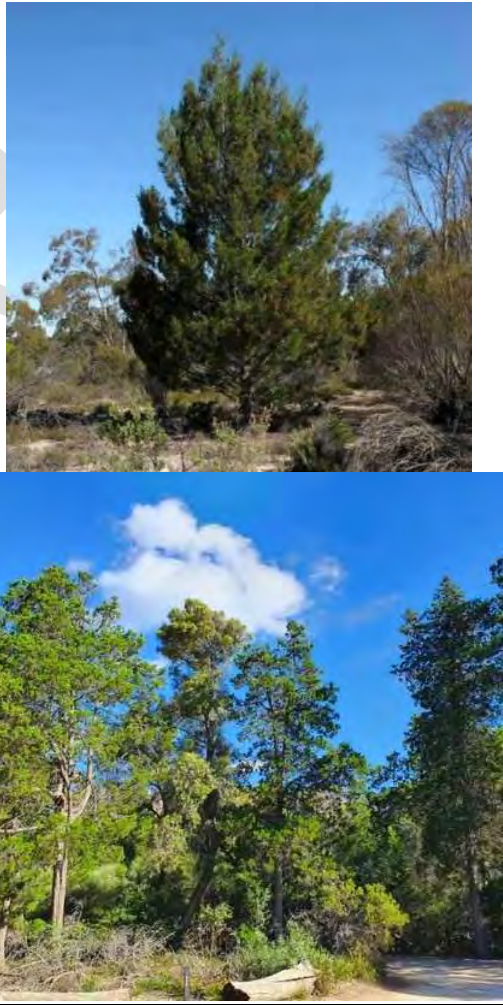
| <p>Black peppermint dry forest and woodland on sandstone vegetation community, with an understorey featuring bracken fern and silver banksia.</p> | <p>Blue gum dry forest and woodland vegetation community, photographed from the fence line. This area was not formally field verified as it lies outside the TI irrigation area.</p> | <p>Oyster bay pine forest vegetation community, photographed from the fence line. This area was not formally field verified as it lies outside the TI irrigation area.</p> |

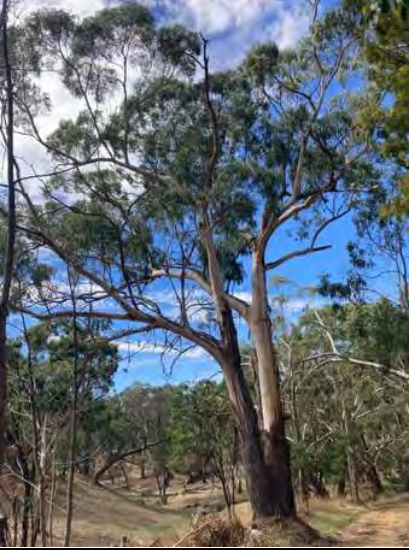
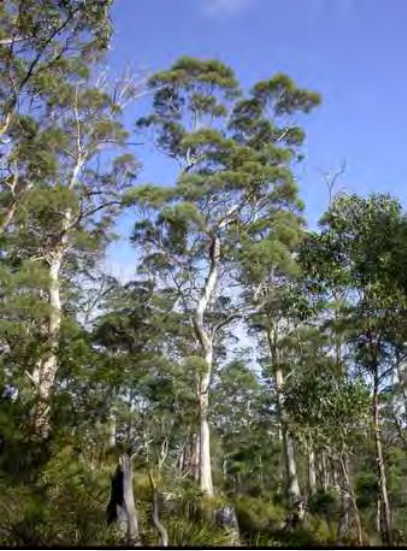
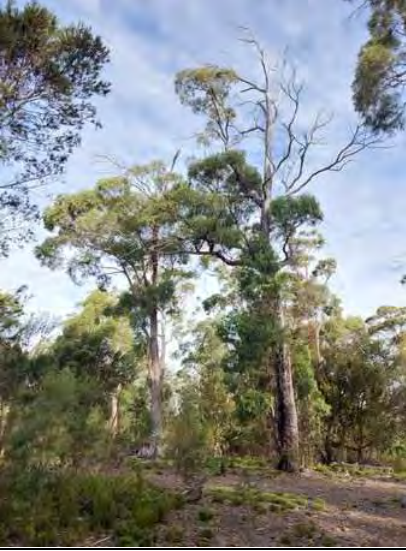
| <p>White gum trees dispersed along a minor drainage depression, showing tussock understory.</p> | <p>White peppermint dry forest and woodland community featuring a spiny-headed mat-rush dominated understory.</p> | <p>Black peppermint dry forest/woodland on dolerite vegetation community, photographed from the fence line. This area was not formally field verified as it lies outside the TI irrigation area.</p> |

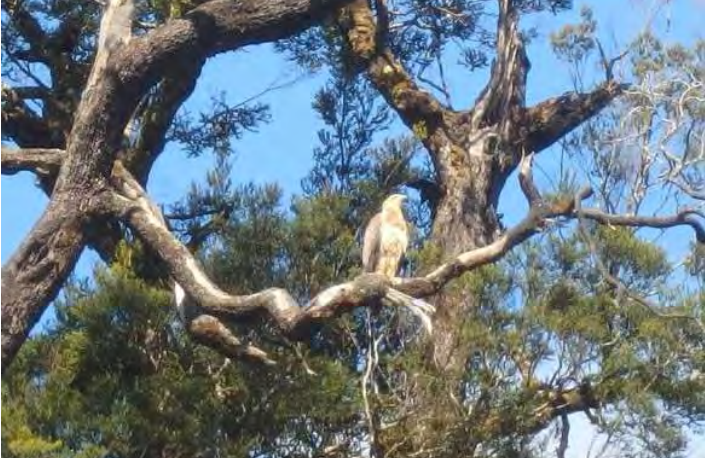
| White-bellied Sea-Eagle shown for <b>reference only</b> . | White-bellied sea eagle observed during the field survey within the northern section of the TI irrigation area, perched in a mature white peppermint tree. | |

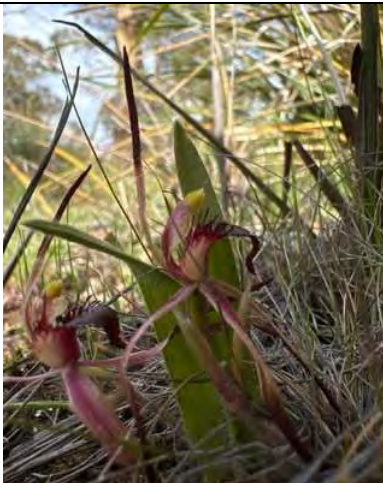
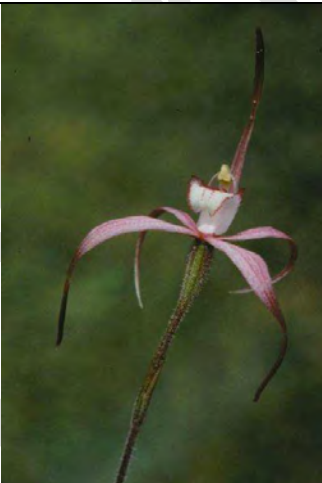
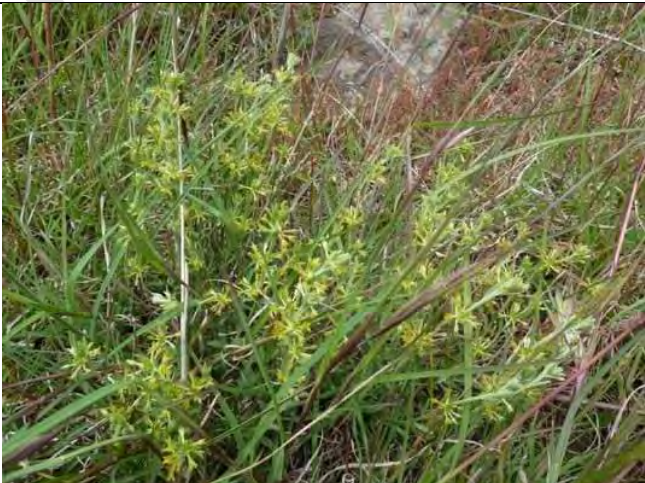
| Two tailed spider-orchids observed during the field survey within the northern section of the TI irrigation area. | Rosy spider-orchid observed during the field survey within the central section of the TI irrigation area. | Eight slender curved rice flowers observed during the field survey within the central section of the TI irrigation area. |

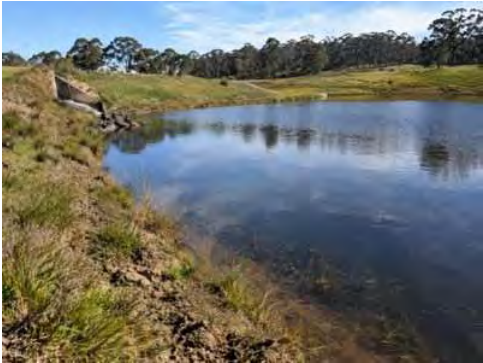
| Dam 1 (makes up a portion of Seabyrne Creek), some bank erosion from sheep trampling is visible. | Minor Tributary (including Waterhole 6) in the northern section of the TI irrigation area. | |

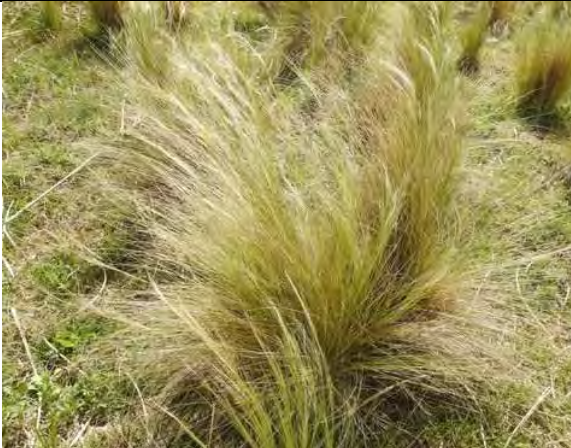
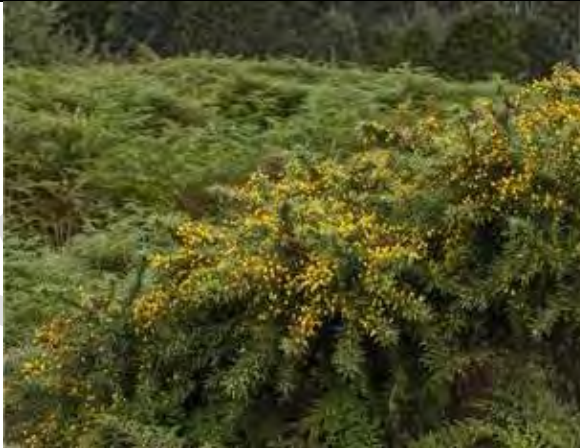
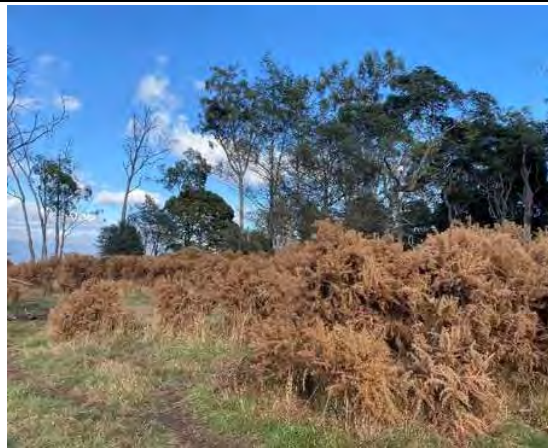
| Cluster (approx. 15 plants) of serrated tussocks observed during the field survey within the northern section of the TI irrigation area. | A section of gorse amongst bracken fern vegetation. | Evidence of recent gorse spraying amongst the Bracken fern vegetation area. |
